Analyzing the degradation of roadside infrastructure

Luke Strand Augustine

A THESIS

Department of Civil Engineering
College of Engineering

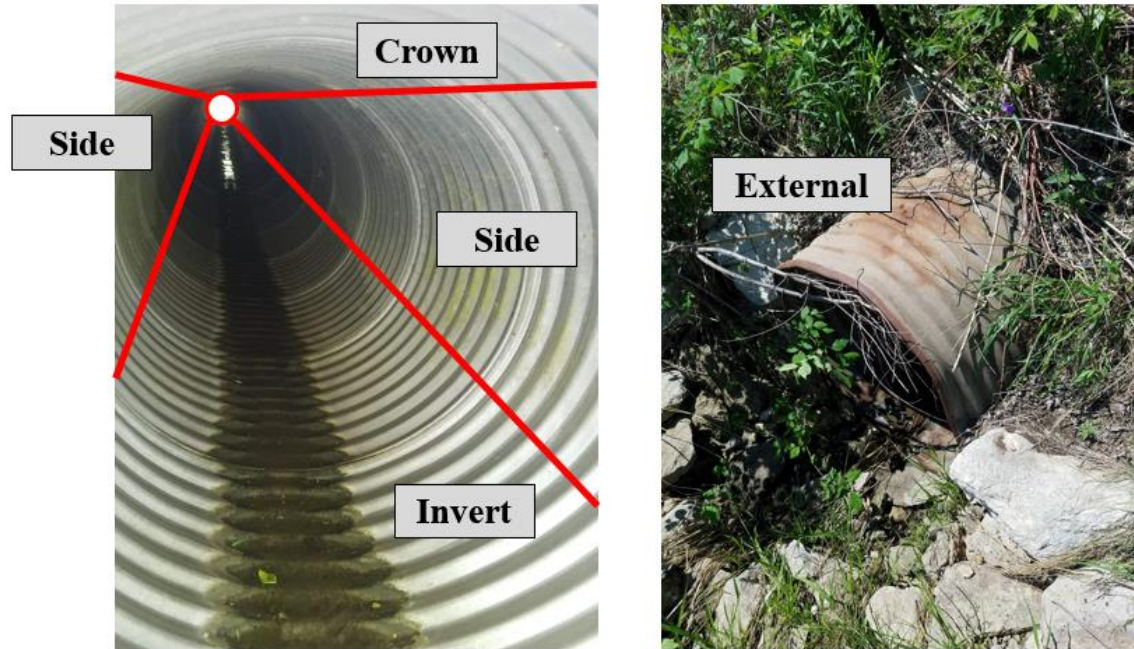
Fig. 3.2 Corrugated metal pipe faces

The visible corrosion of most CMPs analyzed in this study was not uniform over the entire surface. In order to more accurately record the observed corrosion, each end of all of the CMP were divided into four different faces. The divided faces, found in Fig. 3.2, were labeled crown, side, invert, and external. The interior of the CMPs had more divisions than the exterior because the interior exhibited more varied levels of corrosion throughout. In addition to the division of the ends, each end of all CMPs were rated because some pipes exhibited different levels of corrosion at each end. Each end was assigned the letter *A* or *B*, based on the relative

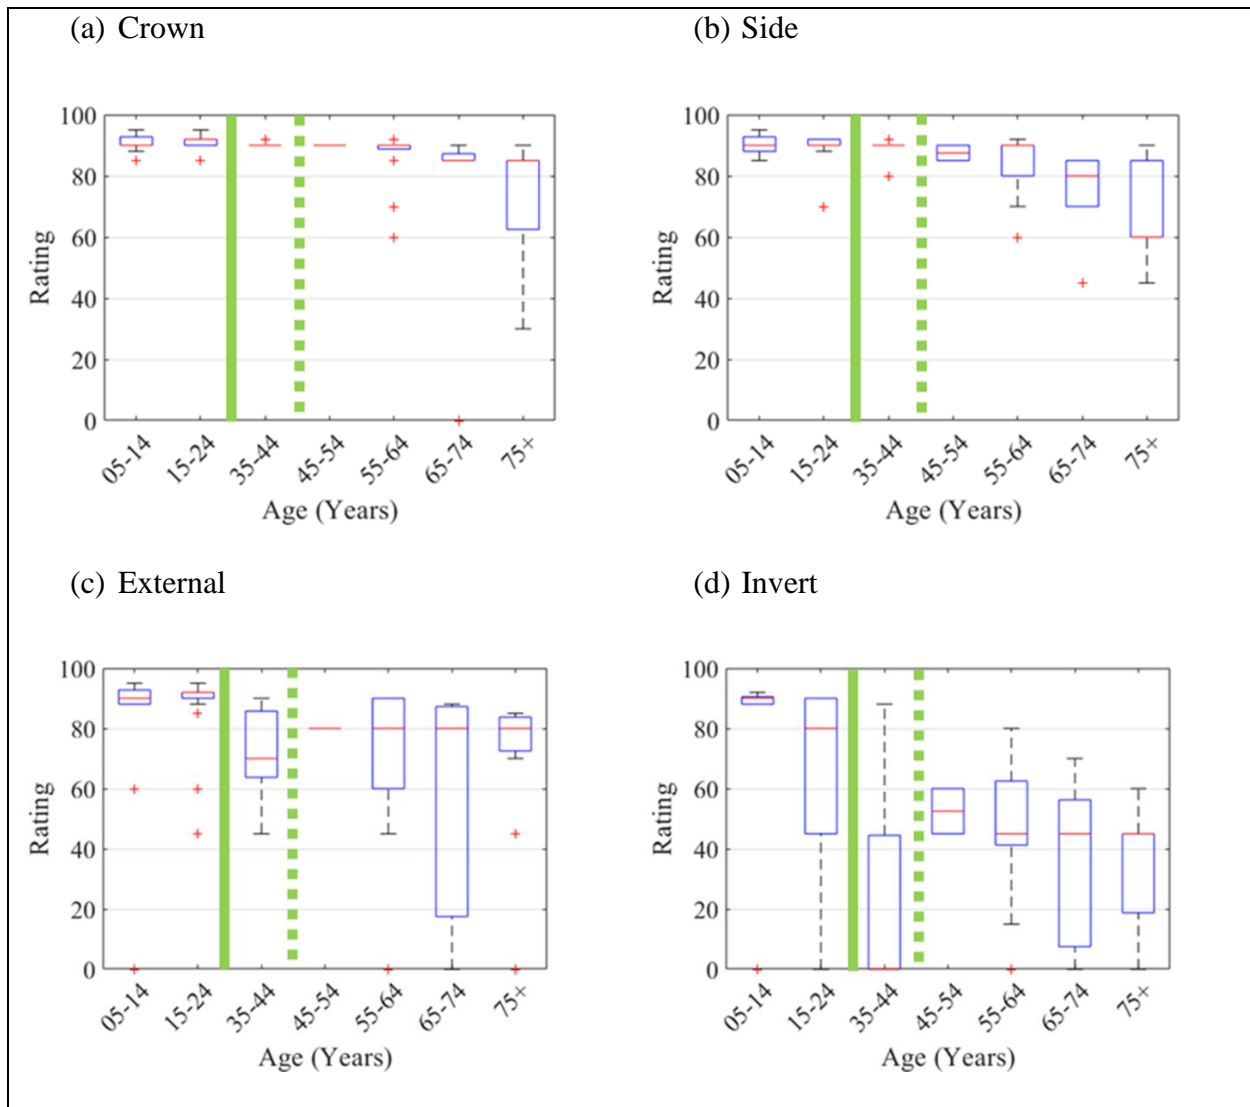
Fig. 4.3 Corrosion ratings grouped by age, (a) external, (b) crown, (c) side, (d) invert

The crown of the observed CMP showed a decline in the corrosion as age increased (Fig. 4.3a). This was an expected decline as material will degrade over time after installation. The side of the CMP also showed a similar decline in rating as age increased (Fig. 4.3b). The external face of the CMP had a much higher variance in rating (Fig. 4.3c). However, this variance does not necessarily indicate that corrosion was the only factor. Many of the CMP observed had

crumpled exteriors, likely a result of impact from a tractor or other vehicle. The crumpled exteriors created surfaces for water to be caught on, artificially accelerating the rate of corrosion on the exterior of the CMP.

The CMP face with the highest variability was the invert (Fig. 4.3d). This variability was attributed to differing levels of corrosion. Many of the inverts contained sediment, fostering a setting that increases the rate of corrosion due to the deprivation of oxygen and increased contact with moisture. The covered areas of the CMP became more anodic relative to the uncovered areas of the CMP, creating an electrode potential imbalance and leading to accelerated corrosion (Cicek 2014).

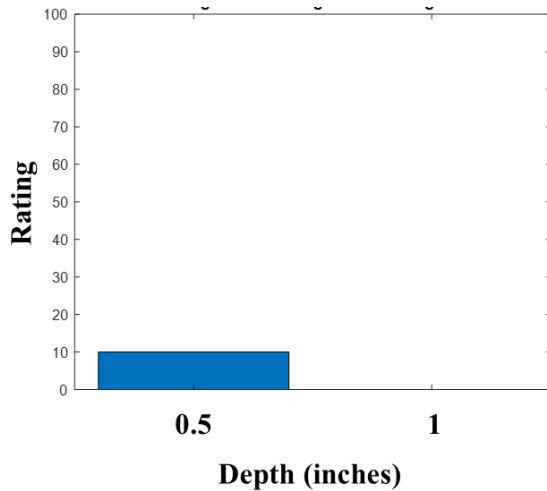
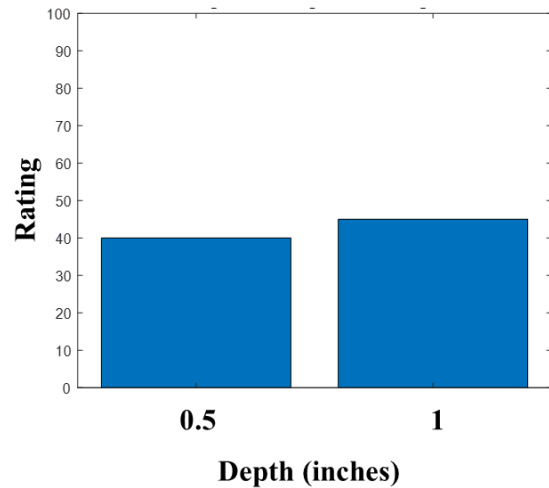
Fig. 4.4 Average invert rating with corrugation depth (a) age 35-44, (b) age 75+

The invert was determined to be the most valuable component when analyzing the corrosion of CMP due to its high variability and non-linear changes across age groups. Therefore, CMP characteristics believed to further contribute to corrosion were selected to measure against the invert ratings. The first characteristic chosen was the corrugation depth because of the capacity for deeper corrugations to trap more sediment in the invert. Only two corrugation depths, 0.5 inches (13 mm) and 1 inch (25 mm), were measured in this study. The 1 inch (25 mm) corrugation depth was only found in two age groups, 35-44 and 75+ years old (Fig. 4.4), and was far less common than the 0.5 inch (13 mm) corrugation depth; only 1 out of 80 had a depth of 1 inch (25 mm). In Fig. 4.4a, the average invert rating for 1 inch (25 mm) depth is zero because each CMP invert in this age group with a depth of 1 inch (25 mm) was rated zero. Fig. 4.4 results are inconclusive because one depth dimension does not have higher invert ratings in both age groups.

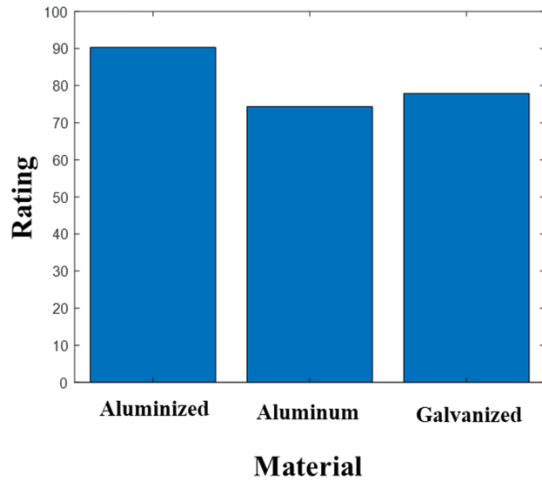
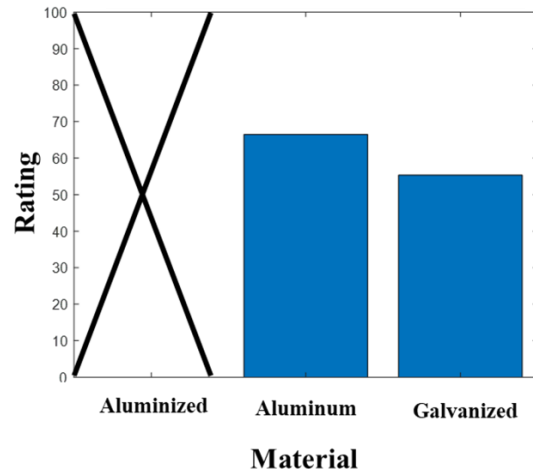
Fig. 4.5 Average invert rating with material type (a) age 05-14, (b) age 15-24

The second characteristic chosen to measure against invert rating was the CMP material (Fig. 4.5). Only two age groups were analyzed because only the 5-14 and 15-24 year old age groups had materials alternative to galvanized CMP. This is a result of KDOT's policy for not allowing anything but galvanized CMP prior to 2001 (Stratton et al 1990). The three material types analyzed were galvanized, aluminized, and aluminum. In Fig. 4.5b, no aluminized CMP were observed. From Fig. 4.5, it can be seen that while one material does not rate the highest in both age groups, traditional galvanized CMP is not the highest rated CMP in either age group.

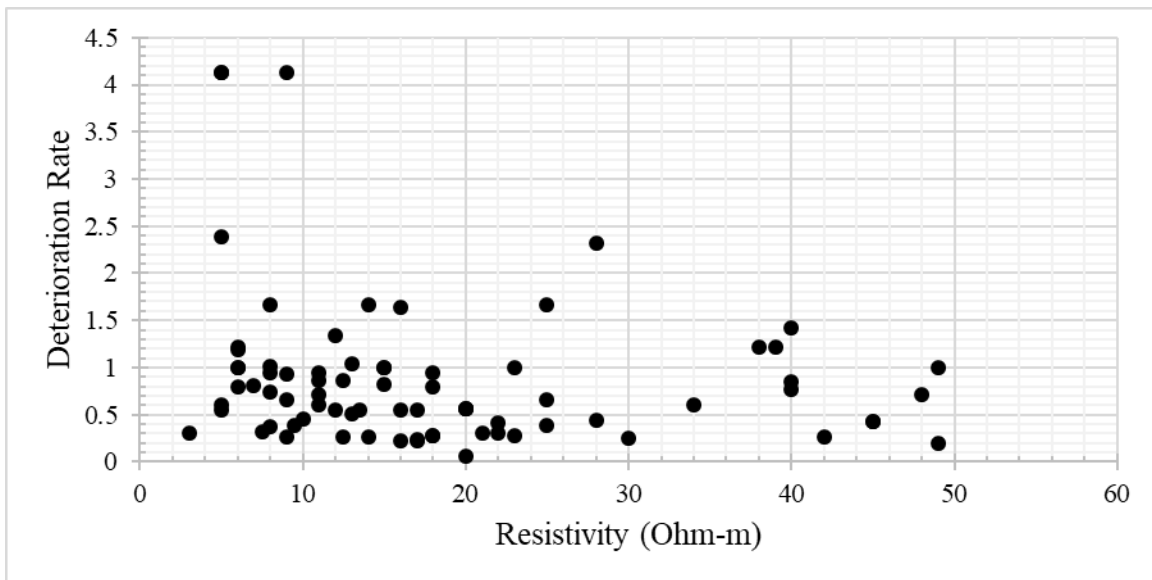
Fig. 4.6 Deterioration rate versus resistivity

Two properties of the soil surrounding the CMP were investigated in an attempt to find an indicator of expected deterioration rate. Electrical resistivity was first chosen because it is accepted as an indicator of corrosive environments and is used in California Test 643 as an estimator for CMP service life (Vilda, 2009). From the data collected, shown in Fig. 4.6, there was no correlation between resistivity and the deterioration rate of CMP. This is significant because electrical resistivity is commonly used to predict corrosion and has been for decades (Vilda, 2009).

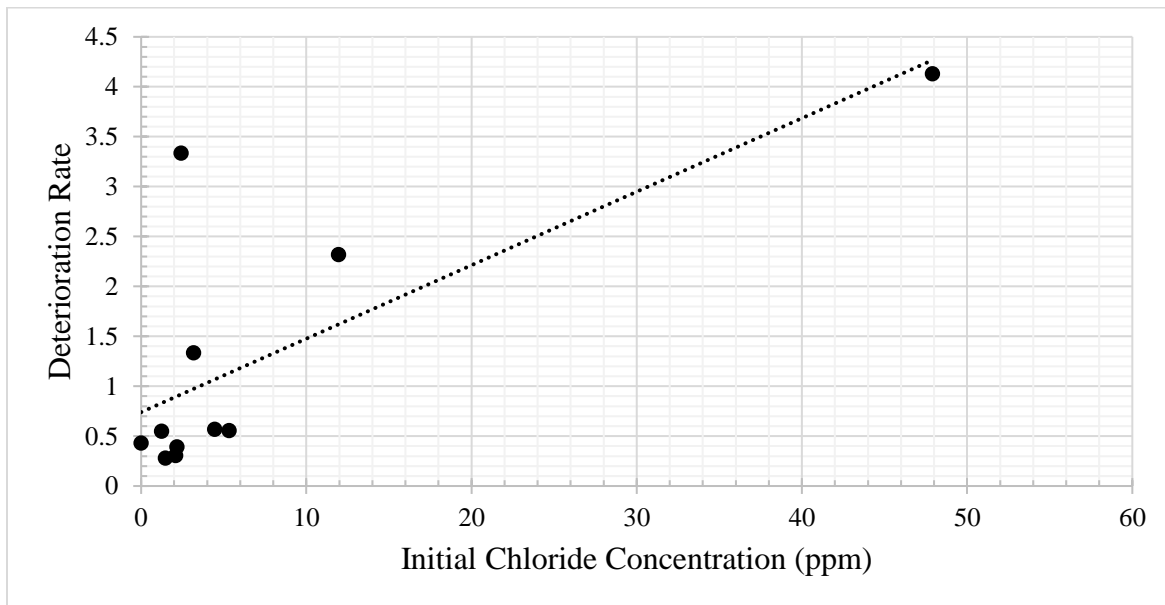
Fig. 4.7 Deterioration rate versus initial chloride concentration from CMP sampled in the fall/winter

The second property of the surrounding soil chosen for analysis was the chloride concentration present. This property was chosen because of small trial conducted by Crowder (2017) indicated there is possible correlation between the deterioration and chloride concentration. For this study, soil samples from eleven CMP were collected during the fall/winter before any snow had fallen. The initial chloride concentrations, extracted the day of collection, against the deterioration rate can be found in Fig. 4.7. With no consideration for outliers, the coefficient of determination was found to be 0.558. With the removal of the one apparent outlier of the initial chloride concentration of 2.42 ppm and deterioration rate of 3.33, the coefficient of determination rose to 0.881. Causes that may have led to outlying data were investigated including precipitation in the days prior to sample collection and observation and relative roadway traffic volume. However, no justification was found.

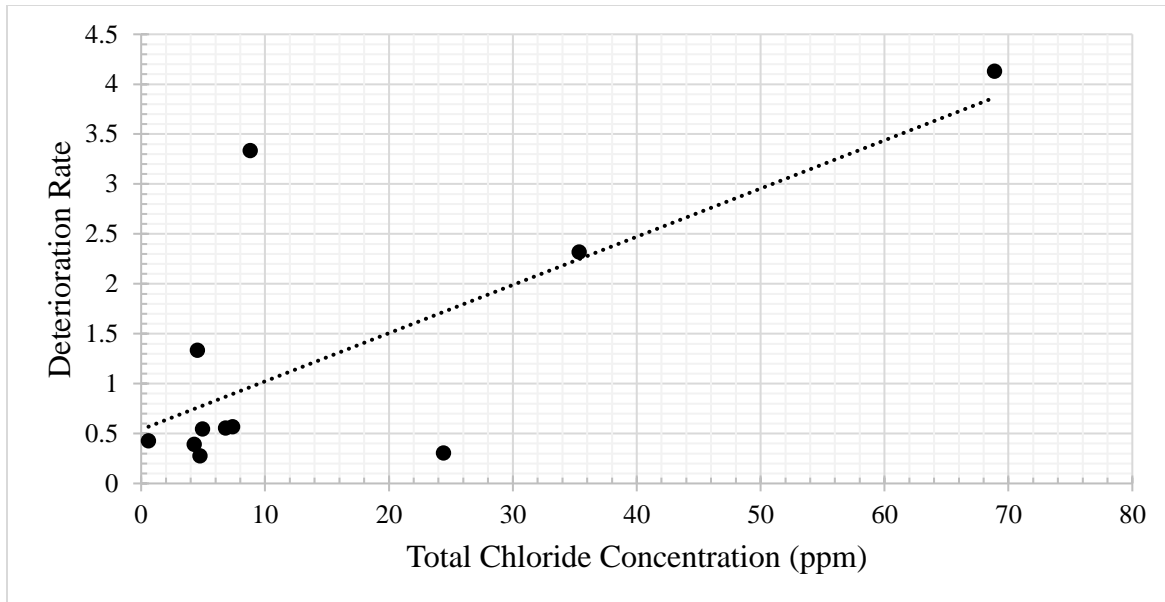
Fig. 4.8 Deterioration rate versus total chloride concentration from CMP sampled in the fall/winter

Total chloride concentration was also measured against the deterioration rate. The resulting graph can be found in Fig. 4.8. The total chloride concentrations were calculated from

the chloride mobilized through repeated washing of the soil. With no consideration for outliers, the coefficient of determination was found to be 0.531. With the removal of the one apparent outlier, the same data point as previously described, the coefficient of determination rose to 0.826. From both the initial and total chloride concentration analyses, it can be concluded that chloride may be used as a good indicator of CMP deterioration rates in Kansas.

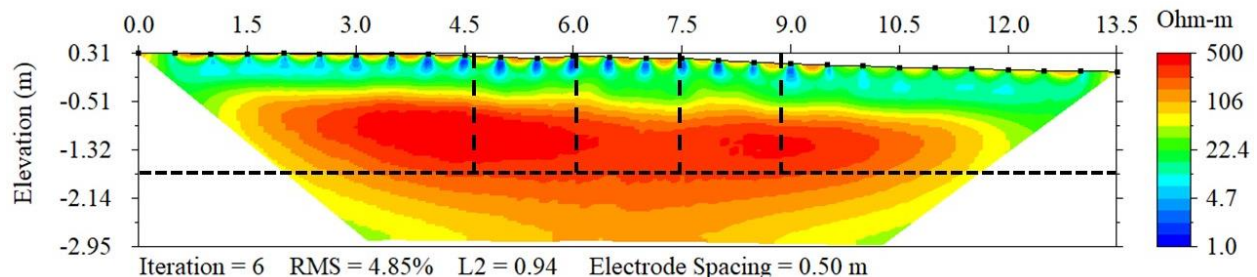
Fig. 4.9 Dipole-Dipole array with 0.5 m spacing at Lee Blvd, Leawood, Kansas

The first wall investigated in this study was located at the Lee Blvd overpass of I-435 in Leawood, Kansas. This wall is adjacent to a park. This wall was topped with grass, allowing for top-of-the-wall surveys to be conducted. Both Dipole-Dipole and Schlumberger arrays were used at the top of the wall with electrode spacings of 0.5 m, 1 m, and 2 m in order to obtain a bulk characterization of the backfill and the soil underlying the MSE wall, as well as image the possible layer of fine soil particles collecting at the base of the wall. Both the Dipole-Dipole and Schlumberger arrays were used because of their different advantages. No Dipole-Dipole array with an electrode spacing of 2 m was used for analysis because of data collection error. Fig. 4.9 shows the results from the Dipole-Dipole array with a 0.5 m electrode spacing. The horizontal dotted line represents the base of the wall. The four vertical dotted lines represent the location of the four electrodes used for the into-the-wall survey. It shows a highly resistive material with a range of resistivity between 400 Ohm-m and 700 Ohm-m. This range of values is indicative of a gravel (Palacky, 1987).

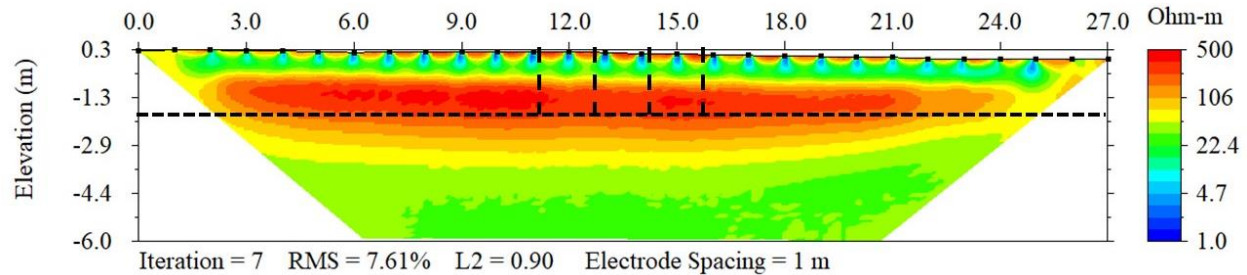
Fig. 4.10 Dipole-Dipole array with 1 m spacing at Lee Blvd, Leawood, Kansas

With a spacing of 1 m, the second Dipole-Dipole array, shown in Fig. 4.10, measured a similar, highly resistive material in the backfill of the MSE wall. Underlying the wall base (shown with the dashed line) is a material with a much lower resistivity between 35 Ohm-m and 50 Ohm-m. This is indicative of sandy clay. The two Dipole-Dipole surveys do not show a sharp interface between the backfill and the underlying soil.

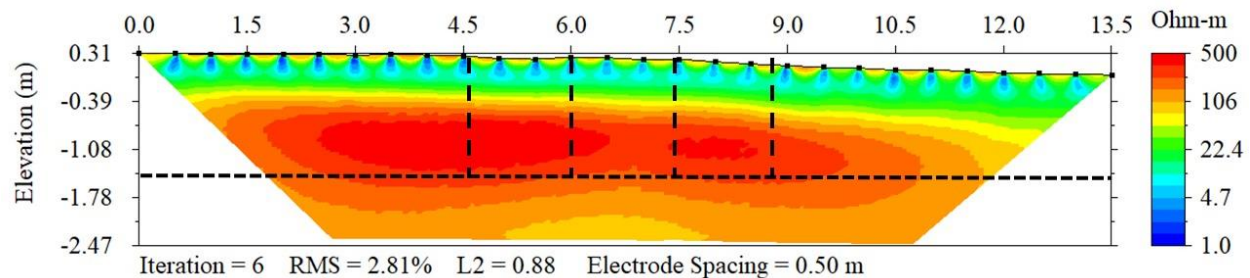
Fig. 4.11 Schlumberger array with 0.5 m spacing at Lee BLVD, Leawood, Kansas

The results of the Schlumberger array performed at a spacing of 0.5 m, shown in Fig. 4.11, measured the backfill resistivity between 350 Ohm-m to 620 Ohm-m. This range of values for the backfill is comparable to those obtained by both of the Dipole-Dipole arrays. The backfill resistivity is indicative of gravel.

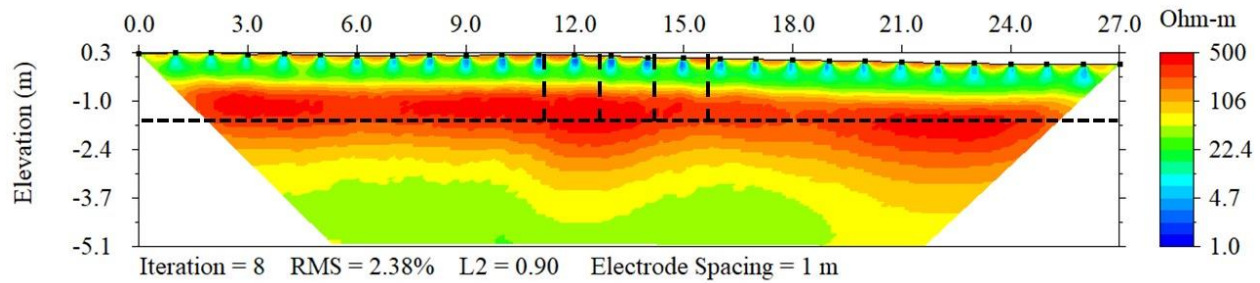
Fig. 4.12 Schlumberger array with 1 m spacing at Lee BLVD, Leawood, Kansas

Fig. 4.12 shows the results of the Schlumberger array taken with an electrode spacing of 1 m. The range in resistivity values for the backfill were 250 Ohm-m to 600 Ohm-m, again indicating gravel backfill. The lower end of the range was found at the base of the wall, indicating the possible presence of moisture in the backfill.

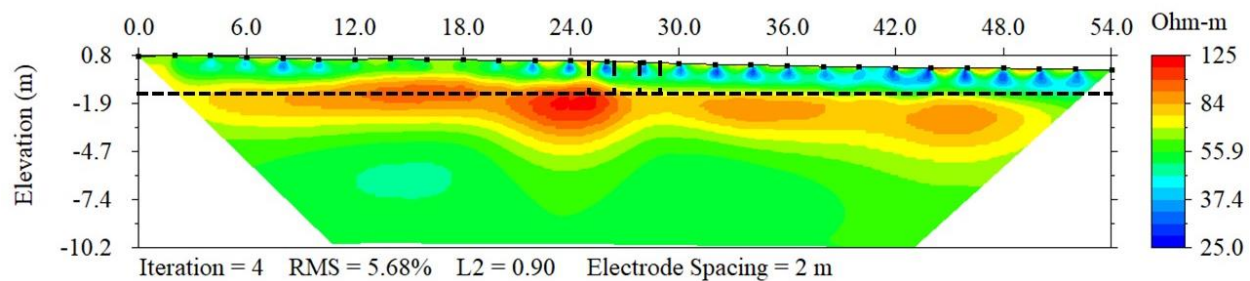
Fig. 4.13 Schlumberger array with 2 m spacing at Lee BLVD, Leawood, Kansas

The final electrical resistivity survey taken at this wall was a 2 m spaced Schlumberger array with the results displayed in Fig. 4.13. This survey was conducted to better image the soil underlying the wall. The resistivity of the underlying soil ranged from 60 Ohm-m to 50 Ohm-m. These relatively low values are indicative of sandy or silty clay with moisture.

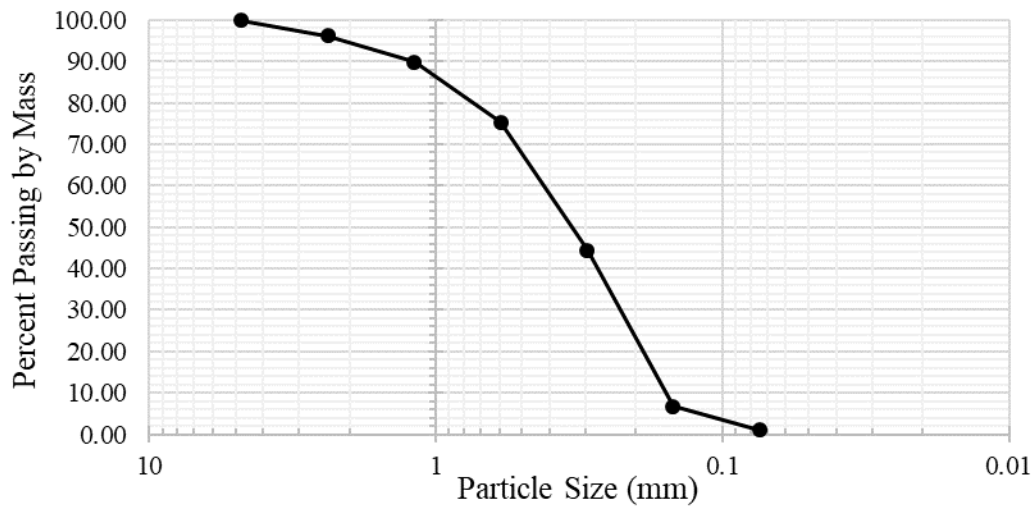
Fig. 4.14 Grain size distribution of MSE wall backfill at Lee Blvd, Leawood, Kansas

The classification of the MSE wall backfill collected at the base of the wall was poorly graded sand. The grain size distribution can be found in Fig. 4.14. It contained an *in situ* moisture content of 15.6%. The degree of saturation was calculated to be 51.7%. These laboratory tests are supportive of the into-the-wall measurements taken indicating wet sand. They also show that the surveys taken at the top of the wall were not effective at precisely revealing the conditions at the base of the wall. Neither array type or electrode spacing were more effective than the other in imaging the conditions at the base of the wall from a top survey. The resistivity of the backfill may have been increased due to the proximity of the survey to the wall face; being too close to the wall face will generate higher resistivity measurements (Snapp et al., 2017). However, these surveys were conducted at least one electrode spacing away from the wall face in order to neglect the effect of the wall face on the survey.

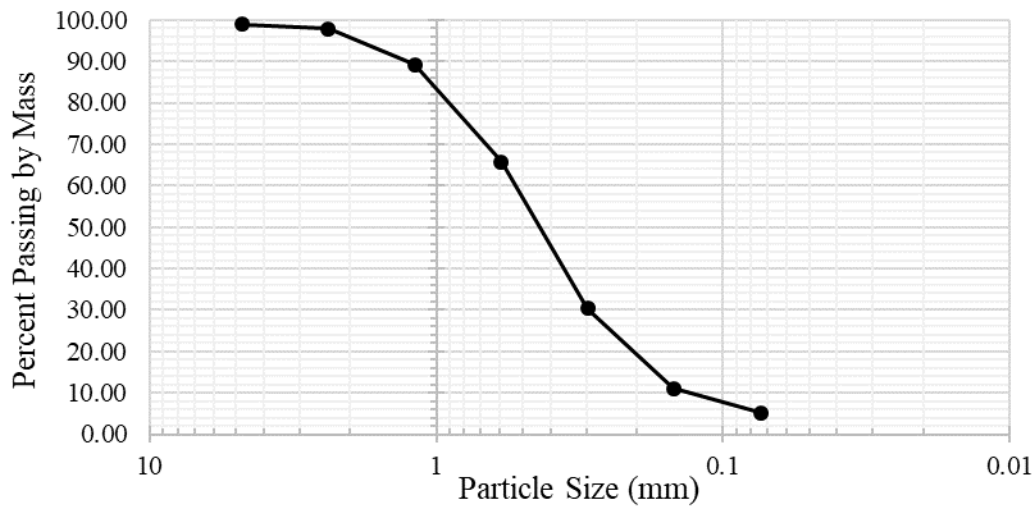
Fig. 4.17 Grain size distribution of MSE wall backfill at US-24 and Camp Creek Rd, Belvue, Kansas

The classification of the backfill was poorly graded sand with an *in situ* moisture content of 6.4%. The degree of saturation was calculated to be 21.2%. The grain size distribution can be found in Fig. 4.17. The findings from the laboratory tests are supportive of the into-the-wall measurements that were taken indicating sand with moisture. Compared to the MSE wall at Lee Blvd, the backfill had similar gradation but had a lower moisture content and degree of saturation. Additionally, the erosion of backfill causing heterogeneous air pockets that may exist where the survey was conducted would also increase the measured resistivity. The established relationship of saturation and resistivity supports the higher resistivity due to the lower moisture content. Air voids may have also influenced the increase in resistivity. Both sets of measurements are reasonable for their respective conditions.

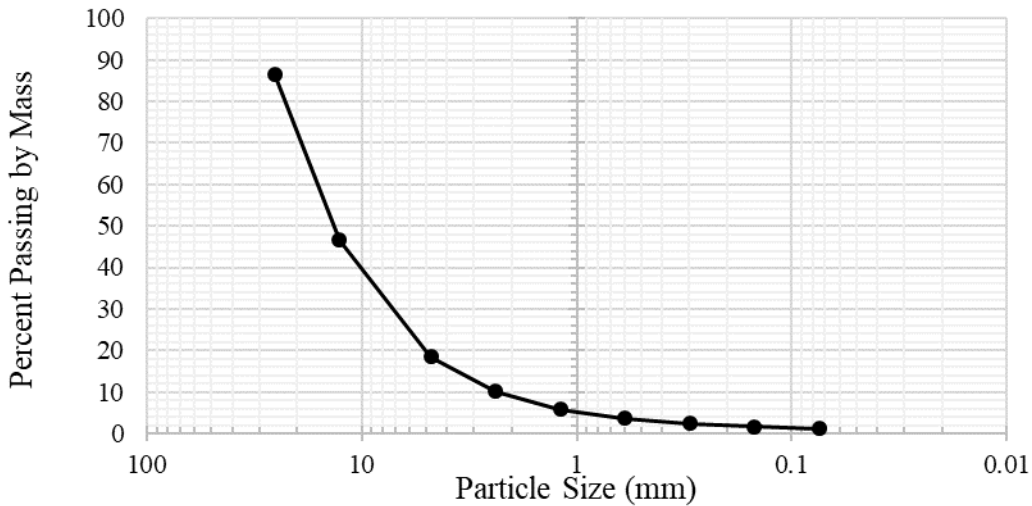
Fig. 4.18 Grain size distribution of MSE wall backfill at US-75 and 46th St., Topeka, Kansas

The classification of the backfill was poorly graded gravel. The calculated degree of saturation was 41.5%. The grain size distribution can be found in Fig. 4.18. The *in situ* moisture content was 4.7%. This classification does not support the into-the-wall measurements that predicted wet sand. Rather, this classification more reasonably supports the single Dipole-Dipole measurement which indicates gravel with some moisture. It would be beneficial to revisit this wall for a second analysis to get more consistent measurements. Each wall was only

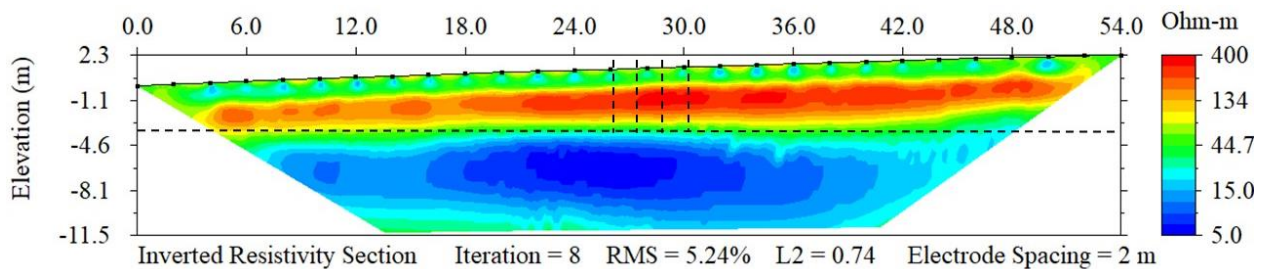
Fig. 4.19 Dipole-Dipole array with 2 m spacing at 151st and I-35, Olathe, Kansas

The MSE wall located at 151st and I-35 was another wall incorporated into an overpass system. This one, however, was topped with soil and could be analyzed from the top as well as the bottom. The results from the top-of-the-wall survey can be seen in Fig. 4.19. The bulk resistivity of the backfill ranged from 150 Ohm-m to 400 Ohm-m, representing a slightly wet to dry sand. The underlying soil ranged from 5 Ohm-m to 35 Ohm-m representing a wet clay or the presence of a groundwater table.

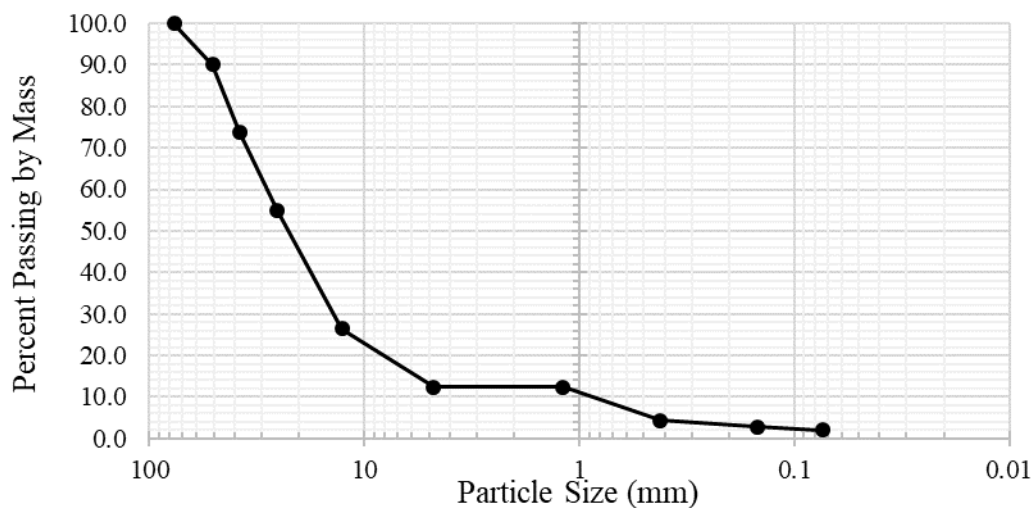
Fig. 4.20 Grain size distribution of MSE wall backfill at K-10 and Ridgeview, Lenexa, Kansas

The classification of the backfill was poorly graded gravel with an *in situ* moisture content of 3.7%. The calculated degree of saturation was 32.7%. The grain size distribution can be found in Fig. 4.20. These results do not support the electrical resistivity measurements gathered. To match the gradation to the resistivity results, the moisture content should be higher or the measured resistivity should be higher.

Previous analysis on this wall was conducted by Snapp et al. (2017) and Brady et al. (2015). A gradation analysis showed the backfill contained over twice the amount of soil particles passing the 4.75 mm (No. 4) sieve than what was collected for the current study (Brady et al., 2015). This increase in small soil particles led to difficulties with laboratory testing conducted by Brady et al. (2015), specifically the testing apparatus did not drain well because of the presence of more small soil particles. The difference in gradation for what was the same wall exposed the limitations of the 2019 study. All of the backfill collected for analysis by the University of Kansas came from directly behind the face of the wall. Little to no backfill was able to be collected from more than 0.3 m from the wall face. This distance was not as far into the wall as the depth of investigation was for the resistivity surveys. The volume measured by resistivity but not collected for laboratory analysis could have contained more fine soil particles. This was in contrast to Brady et al. (2015) and Snapp et al. (2017) where backfill was able to be collected from the entire depth of backfill because it was collected during construction. It also showed that the backfill collected in the 2019 study did not completely reach the maximum depth of investigation of the into-the-wall surveys. For this wall in particular, the maximum depth of investigation was 0.519 m.
